# Manhole Inspection Summary

Manhole # S35II\_050MH

Insp Date: **3/13/07 9:07 AM**

**Location** Address: **1633 CALVERT ST**

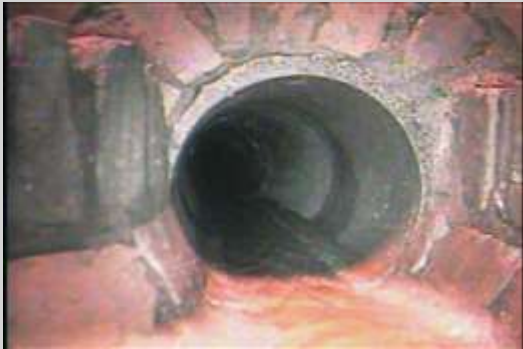
### 8 in. Circular Gravity Sewer Pipe Out @ 12 O'Clock

Pipe Material: **Clay** ☐ Pipe Lined

Invert Depth: **8.48** (ft.) Flow Characteristics: **Slow**

Deposits: ☒ None ☐ **Mud** ☐ Sludge ☐ **Debris** ☐ **Grease**

Infiltration: **None** Pipe Seal Cond: **Unknown**

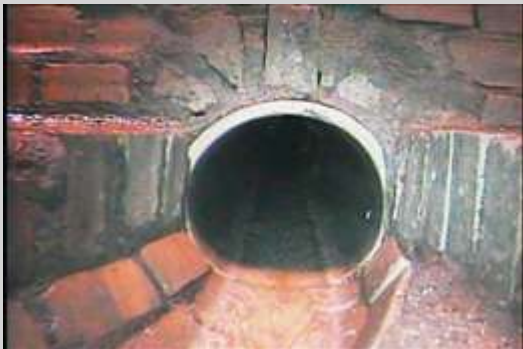
### 8 in. Circular Gravity Sewer Pipe In @ 6 O'Clock

Pipe Material: **Clay** ☐ Pipe Lined

Infiltration: **None** Pipe Seal Cond: **Unknown**
